**Flood Control Project Maintenance  
Levee Inspections**

**Maintenance Issue Types Only, Levee Inspection Report By Mile - Spring 2019**

**Sacramento Maintenance Yard West Levee Yolo Bypass**

Waterway	Bank	Unit Miles	Inspection Start/End	Inspector
Unit No. 01 West Levee	Right	2.73	04/23/2019 04/23/2019	Zach Jojola

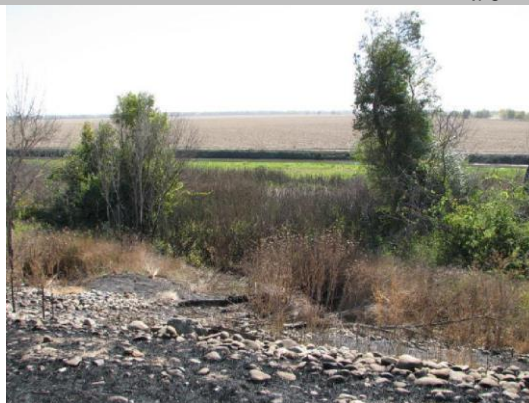
Photo 1 of 3 : UCIP\_SP\_2019\_53232\_60304.jpg

Comment Code					
Inspector Comment					
FS_ID:53232 DS_ID:17742 EP_NO: 10284 Repair Type: No Action Needed Crossing Status: Found UCIP Comments: Screw gates where removed and pipe was abanded by farmer, How pipe was abanded is unknown. Pipe is Grouted FIELD_STRUCT_DESC: 1 of 2: 42-inch corrugated metal gravity drainage pipe through the levee, 23.6 feet below the crown. Slide gate on the waterside (WS) slope. Concrete distribution box at the landside (LS) toe. (42-inch pipe [HLM 2.63] authorized under Automatic Board Order (ABO) issued as Permit No. 10284, 1974 - La Borda and Hoover). [Additional Reference(s): DWR Levee Log, 2004. USACE Sacramento O&M Manual 127, June 1953, (Station 133+82)]. FS Date: 11/16/2018 2:17:55 PM

Waterside view: overview (pipe not found)

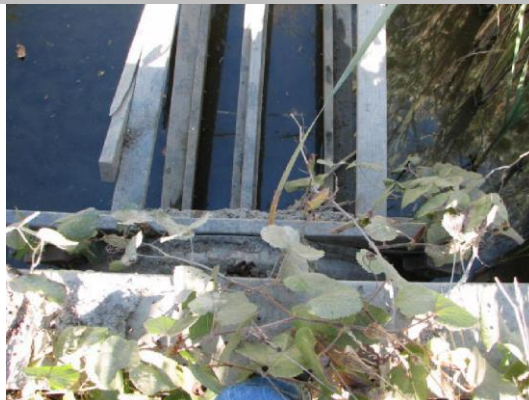
Photo 2 of 3 : UCIP\_SP\_2019\_53232\_60303.jpg

Landside view: concrete spillbox/headwall and pipe (top view)

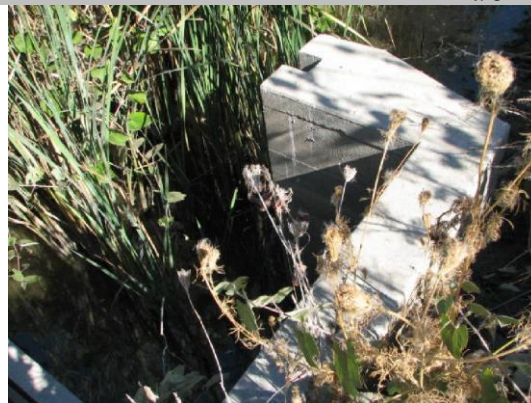
Photo 3 of 3 : UCIP\_SP\_2019\_53232\_60302.jpg

Comment Code						
Inspector Comment						
FS_ID:53232 DS_ID:17742 EP_NO: 10284 Repair Type: No Action Needed Crossing Status: Found UCIP Comments: Screw gates where removed and pipe was abandoned by farmer, How pipe was abandoned is unknown. Pipe is Grouted FIELD_STRUCT_DESC: 1 of 2: 42-inch corrugated metal gravity drainage pipe through the levee, 23.6 feet below the crown. Slide gate on the waterside (WS) slope. Concrete distribution box at the landside (LS) toe. (42-inch pipe [HLM 2.63] authorized under Automatic Board Order (ABO) issued as Permit No. 10284, 1974 - La Borda and Hoover). [Additional Reference(s): DWR Levee Log, 2004. USACE Sacramento O&M Manual 127, June 1953, (Station 133+82)]. FS Date: 11/16/2018 2:17:55 PM

Landside view: side of concrete spillbox/headwall

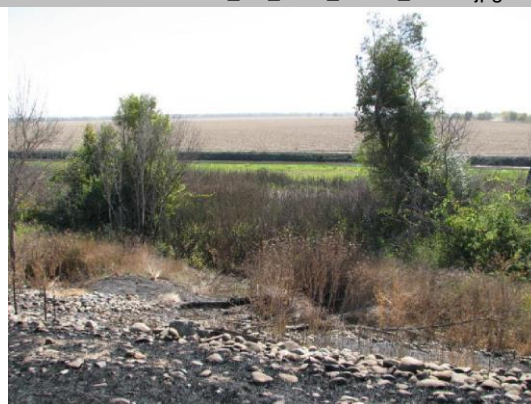
Photo 1 of 3 : UCIP\_SP\_2019\_53233\_60309.jpg

Comment Code						
Inspector Comment						
FS_ID:53233 DS_ID:17747 EP_NO: 10284 Repair Type: No Action Needed Crossing Status: Found UCIP Comments: No slide gate found. slide gates and pipes were abandon by farmer, how unknown FIELD_STRUCT_DESC: 2 of 2: 42-inch corrugated metal gravity drainage pipe through the levee, 23.6 feet below the crown. Slide gate on the waterside (WS) slope. Concrete distribution box at the landside (LS) toe. (42-inch pipe [HLM 2.63] authorized under Automatic Board Order (ABO) issued as Permit No. 10284, 1974 - La Borde and Hoover). [Additional Reference(s): DWR Levee Log, 2004. USACE Sacramento O&M Manual 127, June 1953, (Station 133+82)]. FS Date: 11/16/2018 2:19:35 PM

Waterside view: overview

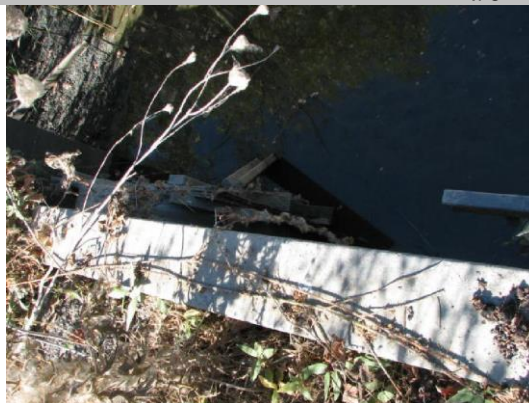
Photo 2 of 3 : UCIP\_SP\_2019\_53233\_60308.jpg

FS\_ID:53233  
DS\_ID:17747  
EP\_NO: 10284  
Repair Type: No Action Needed  
Crossing Status: Found  
UCIP Comments: No slide gate found. slide gates and pipes were abandon by farmer, how unknown  
FIELD\_STRUCT\_DESC: 2 of 2: 42-inch corrugated metal gravity drainage pipe through the levee, 23.6 feet below the crown. Slide gate on the waterside (WS) slope. Concrete distribution box at the landside (LS) toe. (42-inch pipe [HLM 2.63] authorized under Automatic Board Order (ABO) issued as Permit No. 10284, 1974 - La Borde and Hoover). [Additional Reference(s): DWR Levee Log, 2004. USACE Sacramento O&M Manual 127, June 1953, (Station 133+82)].  
FS Date: 11/16/2018 2:19:35 PM

Landside view: concrete spill box

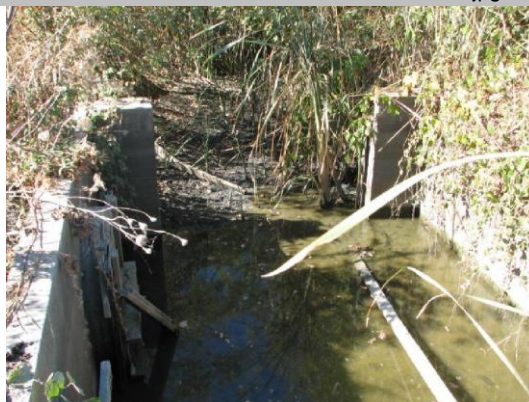
Photo 3 of 3 : UCIP\_SP\_2019\_53233\_60307.jpg

Landside view: CM pipe with flap gate

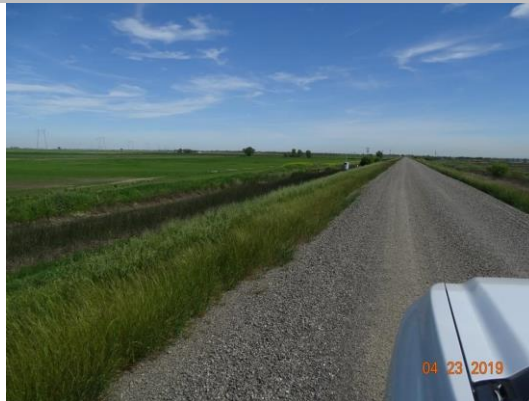
Photo 1 of 1 : SP\_2019\_ST0011\_292\_1\_20190424\_00006.jpg

LM Start	0.00	Rating **	M	Issue No.	1
LM End	1.51	Issue Type +	Ma	Location *	LS
Category	Earthen Levee			GPS Latitude/Longitude	
				Start	End
Item	Vegetation			38.719037 °	38.698644 °
				-121.664097 °	-121.674132 °
DWR ID	DWR_ST0011_02_s_2019_1				
Comment Code					
V1 : Control annual grass and weeds on the levee slopes and easements.					
Inspector Comment

View of vegetation on the landside slope. Spring 2019.

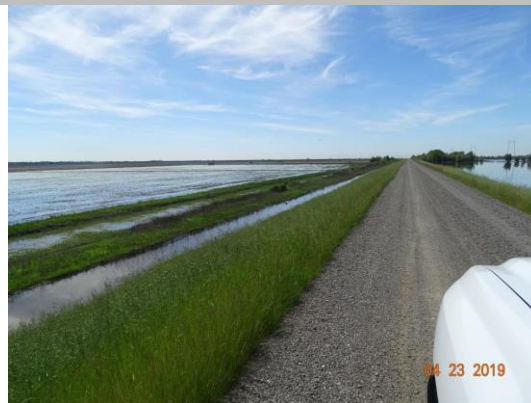
Photo 1 of 1 : SP\_2019\_ST0011\_293\_3\_20190424\_00004.jpg

LM Start	0.01	Rating **	M	Issue No.	3
LM End	0.77	Issue Type +	Ma	Location *	WS
Category	Earthen Levee			GPS Latitude/Longitude	
				Start	End
Item	Vegetation			38.698445 °	38.687494 °
				-121.674113 °	-121.673743 °
DWR ID	DWR_ST0011_03_s_2019_3				
Comment Code					
V1 : Control annual grass and weeds on the levee slopes and easements.					
Inspector Comment

View of vegetation on the waterside slope. Spring 2019.

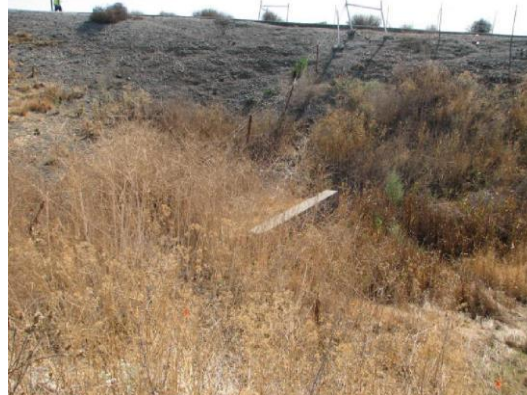
Photo 3 of 3 : UCIP\_SP\_2019\_44826\_60520.jpg

LM Start	0.60	Rating **	A/W	Issue No.	21 (cont)	
LM End	0.60	Issue Type +	Ma	Location *		
Category	Supplemental			GPS Latitude/Longitude		
				Start		End
Item	DWR UCIP LMA Responsibility			38.565704 °		38.565704 °
				-121.638650 °		-121.638650 °
DWR ID	528					
Comment Code						
Inspector Comment						
FS_ID:44826 DS_ID:528 EP_NO: 10304 Repair Type: No Action Needed Crossing Status: Found UCIP Comments: FIELD_STRUCT_DESC: 30-inch corrugated metal gravity drainage pipe through the levee, 22 feet below the crown. Flap gate on the waterside (WS) end. (30-inch pipe [HLM 0.59] authorized under Automatic Board Order (ABO) issued as Permit No. 10304, 1974 - Southern Pacific Transportation Company). [Additional Reference(s): DWR Levee Log, 2004. USACE Sacramento O&M Manual 120, June 1952, (Station 446+08)]. FS Date: 4/28/2015 2:58:55 PM

Landside view: overview

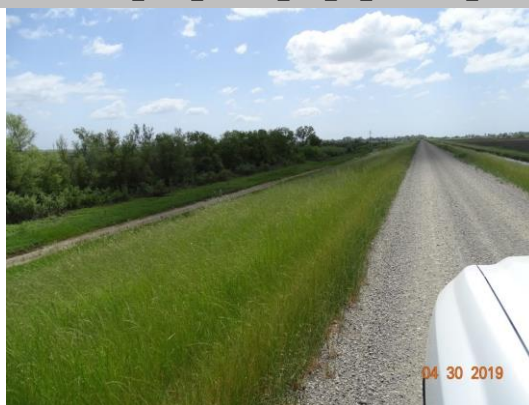
Photo 1 of 1 : SP\_2019\_ST0011\_294\_20\_20190430\_00016.jpg

LM Start	0.91	Rating **	M	Issue No.	20
LM End	3.61	Issue Type +	Ma	Location *	WS
Category	Earthen Levee			GPS Latitude/Longitude	
				Start	End
Item	Vegetation			38.561168 °	38.523743 °
				-121.638160 °	-121.631458 °
DWR ID	DWR_ST0011_04_s_2019_20				
Comment Code					
V1 : Control annual grass and weeds on the levee slopes and easements.					
Inspector Comment

View of vegetation on the waterside slope. Spring 2019.

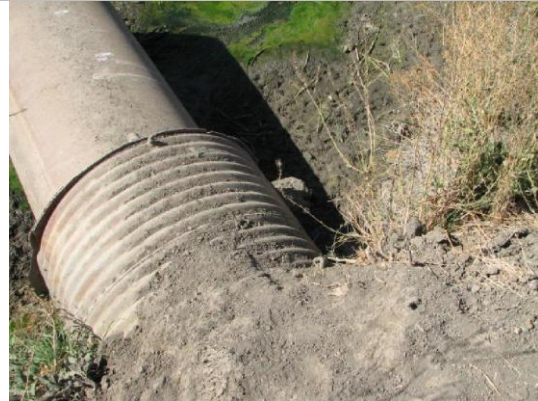
Photo 3 of 3 : UCIP\_SP\_2019\_44822\_24978.jpg

Comment Code						
Inspector Comment						
FS_ID:44822 DS_ID:17736 EP_NO: 10306 Repair Type: No Action Needed Crossing Status: Found UCIP Comments: Farmer cleans this screw gate every year FIELD_STRUCT_DESC: 48-inch corrugated metal gravity drainage pipe through the levee, 21.5 feet below the crown. 42-inch steel pipe inside the 48-inch pipe. Flap gate on the waterside (WS) with two cutoff walls, one headwall, and one saddle and apron. (48-inch pipe [HLM 2.12] authorized under Automatic Board Order (ABO) issued as Permit No. 10306, 1974 - Wells Fargo Bank, Trustees for Cowell Foundation). [Additional Reference(s): USACE Sacramento O&M Manual 119, December 1952, (Station 80+00)]. FS Date: 4/28/2015 2:57:49 PM

Landside view: closer look at 42-inch steel pipe and 48-inch CMP

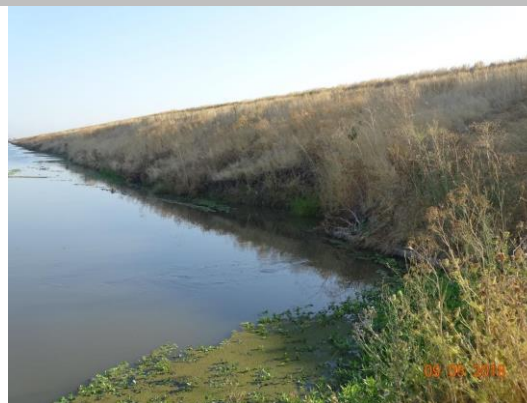
Photo 1 of 1 : SP\_2019\_ST0011\_294\_13\_20190304\_00005.jpg

LM Start	3.61	Rating **	M	Issue No.	13
LM End	3.61	Issue Type +	Ma	Location *	LS
Category	Earthen Levee			GPS Latitude/Longitude	
				Start	End
Item	Erosion / Bank Caving			38.523683 °	38.523683 °
				-121.631463 °	-121.631463 °
DWR ID	DWR_ST0011_04_f_2018_13				
Comment Code					
E2 : Schedule repair of erosion site prior to the next inspection.					
Inspector Comment					
There is erosion on the landside toe because of an irrigation canal. Sac Yard is aware of the issue and intends to fix it.

View of erosion on the landside slope adjacent to irrigation canal. Fall 2018.
